NUMBER 76  
APRIL/MAY  
2002  
\$5.95 U.S.

# Sterndrive Failures

The biggest obstacle to accurate damage-analysis could be your own preconceptions.

**Text and photos by Jonathan Klopman**

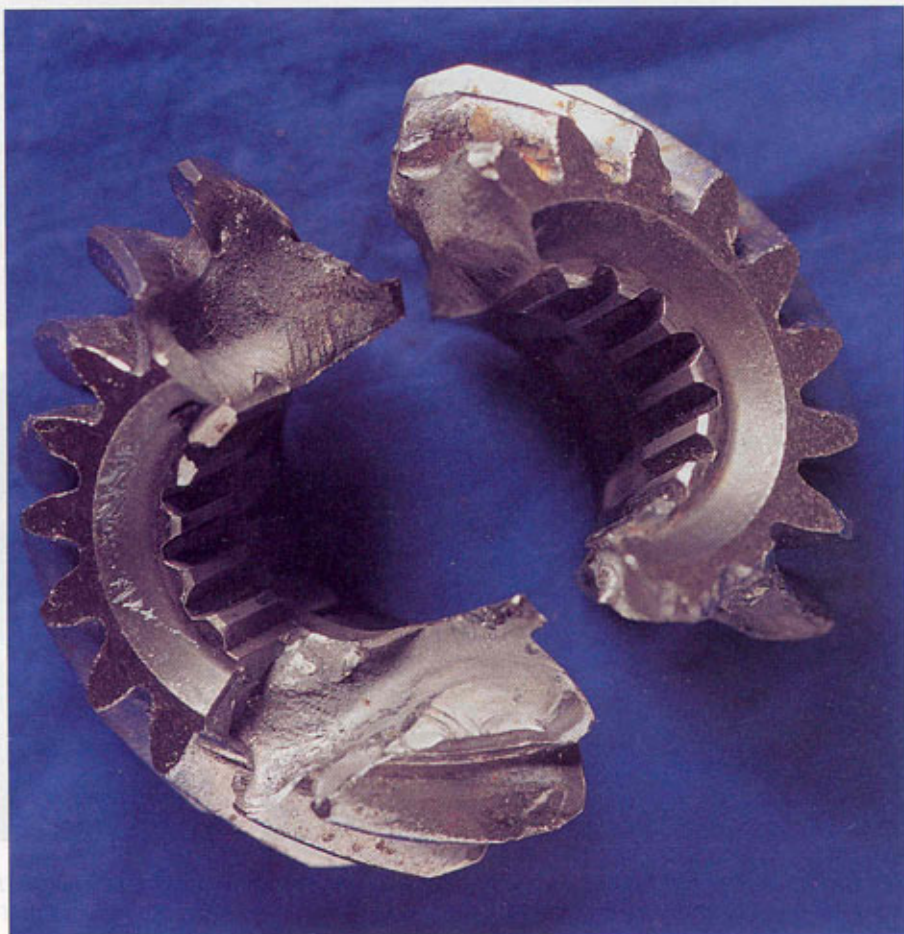
*The split pinion gear pictured here is from an outdrive that struck an object, and was rebuilt without the gear's being replaced. The impact had caused a hairline crack in the gear at the root of one of the teeth. The crack started the fatigue process, which ended in the gear's failure a year later.*

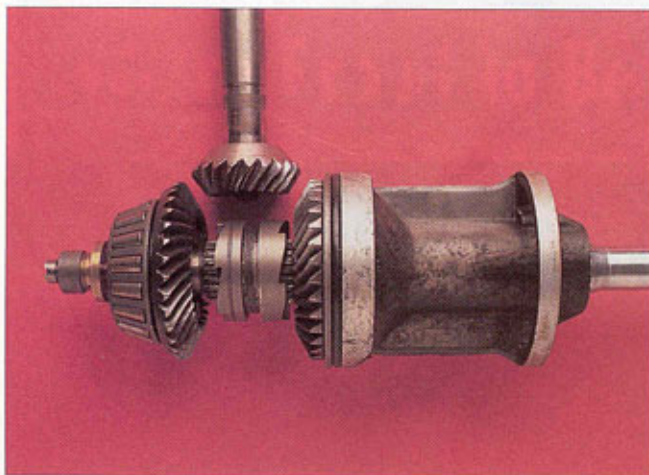
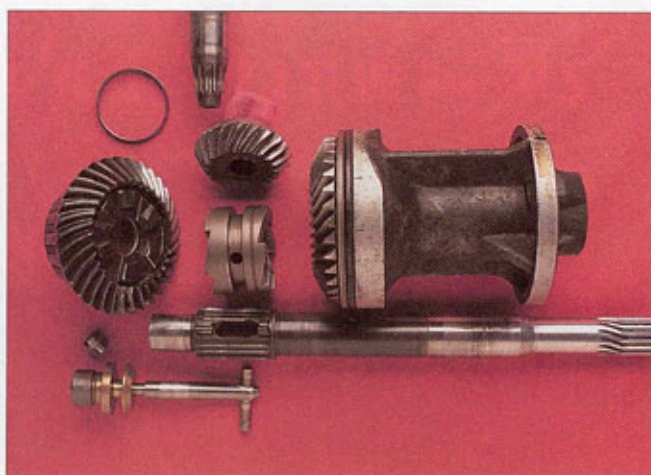
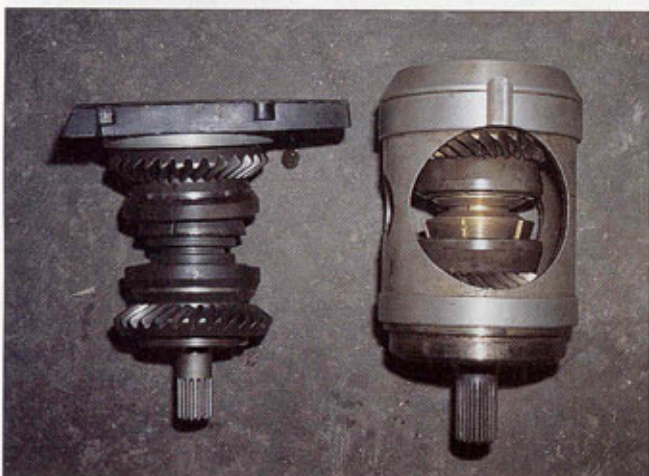
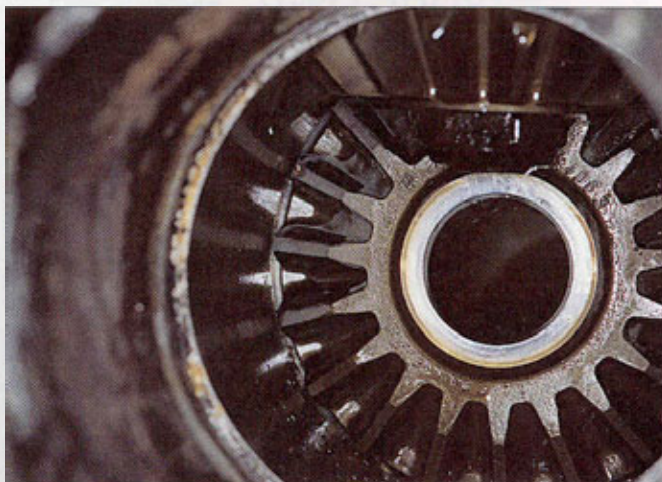
**Top photos, left to right**—The lower-unit drive assembly showing the pinion gear on the vertical drive shaft mated to the forward gear (left) and reverse gear (right), with the clutch dog between the forward and reverse gears; the same parts disassembled. The second photo shows that the unit shifts by sliding the clutch dog along the horizontal prop shaft so that it engages either the forward or reverse gear. The teeth on the clutch dog are not subject to impact damage, but will wear from shifting. **Above, left**—A MerCruiser Bravo cone clutch (left) and an OMC assembly (right). The cone works on friction, and so is prone to wear. **Above, right**—Detail of lower-unit gears on a MerCruiser Bravo drive. The teeth are straight cut and the gears are forged, making them particularly rugged.

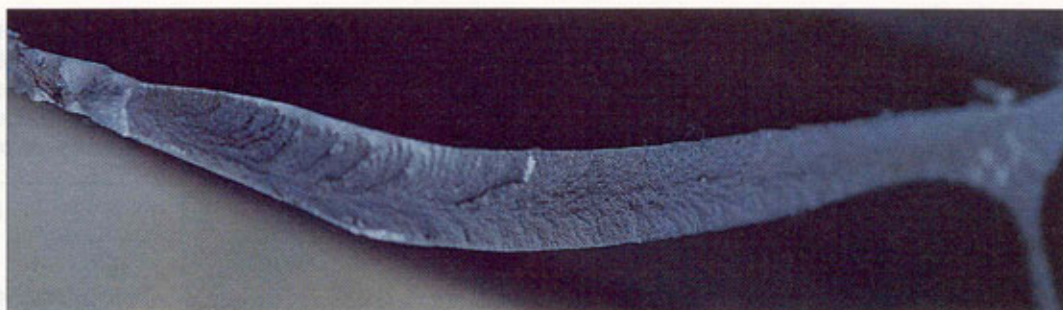
The fracture surface of this broken skeg shows distinct chevron marks pointing back toward the initiation site on the leading edge.

The cast-aluminum case should show evidence of ductile failure along the break, and have a dull and woody texture. In many instances, the fracture will show arrow-shaped chevron marks pointing toward the initiation site of the failure. Although it's certainly possible for the outdrive to strike several rocks in quick succession, it's not typical. The most common break is a single, significant chunk taken out of the bottom of the skeg, with all the clues from the fracture

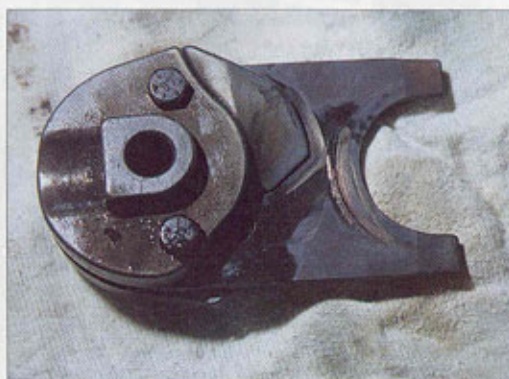
The shift plate on a MerCruiser Bravo drive. The plate is subject to wear, as shown here.

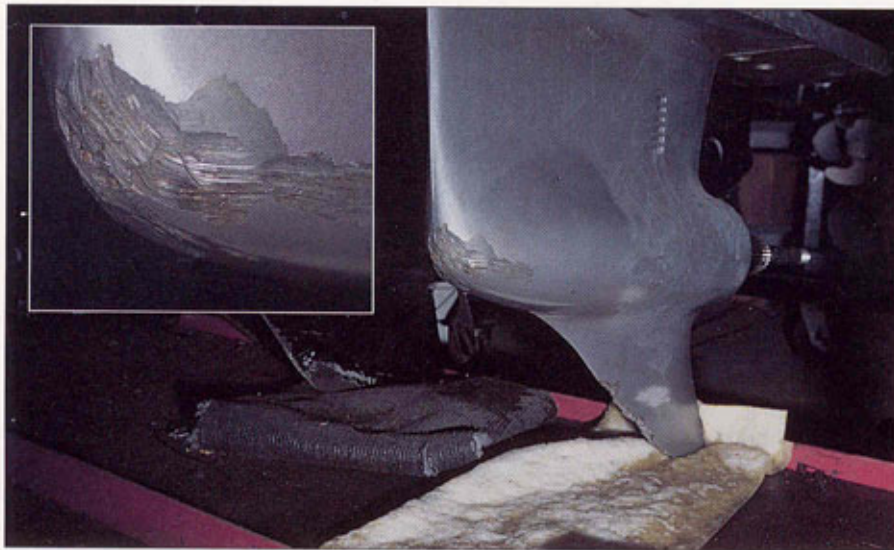
*This Volvo lower unit took a direct hit to the nose of the case. The inset photo shows oil weeping out of the case through a crack caused by the impact. The case is probably beyond repair.*

An impact to the nose that causes a hole in the case, or cracking into the

oil reservoir, is cause to condemn the entire case. Although virtually any material can be welded, it's difficult to find a qualified welder who will be keen about repairing an aluminum casting that has been exposed to 90-weight gear oil and salt water. More often than not, the material is compromised just outside of the weld site, and will crack at a later date.

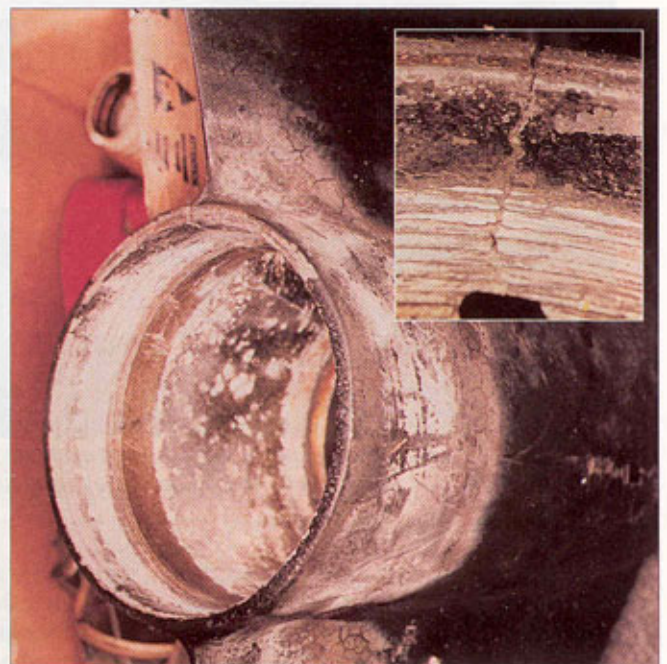
*A MerCruiser lower-unit case with a crack at the top, near the web. First, the inset photo shows that debris has had time to collect in the crack. Second, the crack opens up on the outside of the case. It's most likely that the outdrive was left on during winter storage; the case filled with water and froze, and then cracked when the ice expanded.*

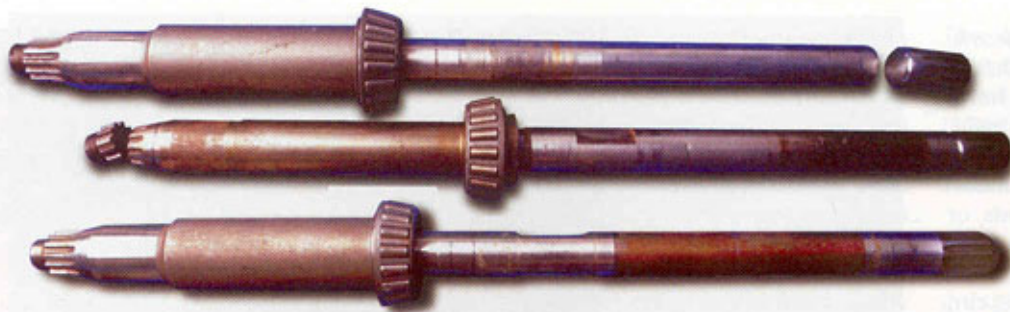
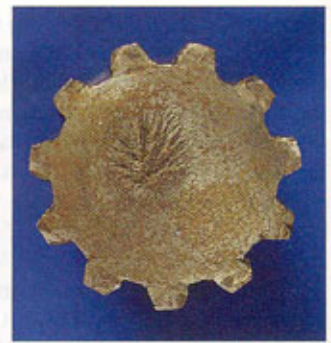
**Above**—Drive shafts from MerCruiser Alpha drives. The shaft at the top is broken at the O-ring groove at the upper splines. The middle shaft's lower-end splines are broken off. The bottom shaft is the most recent model, the MerCruiser Alpha Gen II. The lower-end splines have been reinforced significantly, and there is no O-ring groove machined at the upper splines. **Right**—A detail of the failed lower spline. Here is a good example of a ductile material that failed in pure torsion. The fracture is perpendicular to the axis of the shaft, and the surface is smooth.

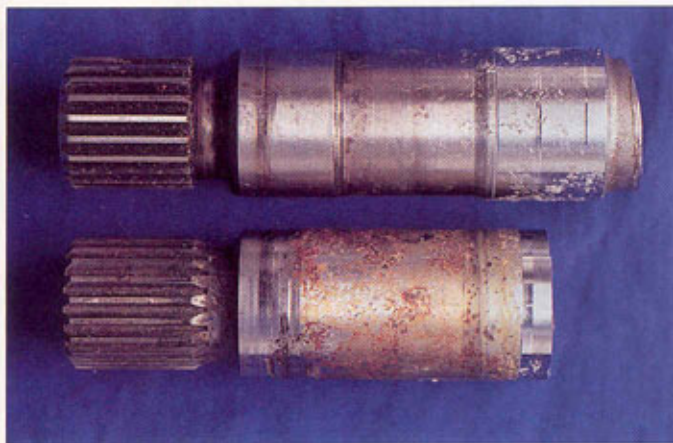
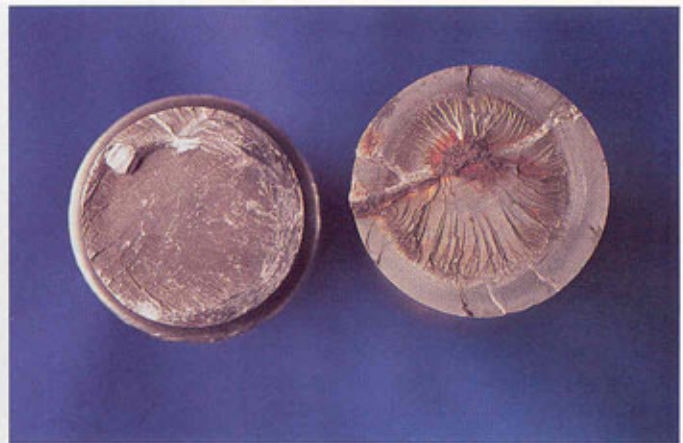
**Left**—Failed upper drive shafts on an older OMC stringer drive. **Right**—End view of the failed shafts. The same parts failed due to the same weak links. The fracture surfaces of both shafts show signs of long-term fatigue.

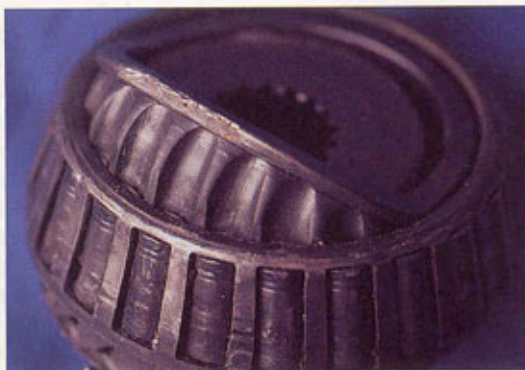
Lack of lube oil in the upper unit of a MerCruiser TRS drive caused the gear and bearing assembly to overheat. The bearing cage got hot enough to flow out from under the bearings. Severe bluing of the steel indicates that the metal reached red-hot temperature.

Lack of adequate lubricant can lead to severe overheating. Because outdrives run in a non-pressurized bath of oil, maintaining the proper oil level is critical. Gravity makes the upper gearcase most vulnerable to oil starvation. In many circumstances, bearings exhibit the first signs of overheat failure. While the tapered rollers themselves are extremely hard, the stamped steel cage that holds them is not. When run dry, the heat in the rollers and race cause the cage to get red-hot and deform. As the cage begins to distort, the rollers tear loose and seize the outdrive.

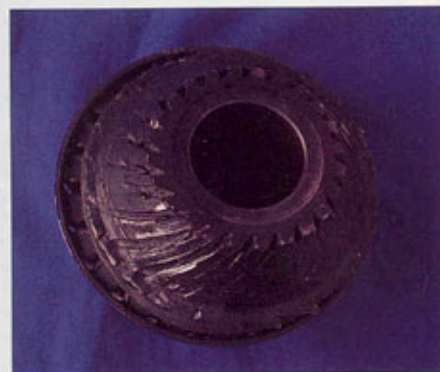
*The driven gear from an Alpha upper unit. While the bearing under the gear appears to have been running in oil, the gears had been run dry. Continued operation of the softened gears led to plastic deformation and massive adhesive wear failure.*

Note that overheated gears turn red-hot, and then cool to a dark blue. Overheating the gear teeth destroys the hardened nitride coating and softens the steel. Along with discoloring, another sign of overheating is adhesive wear on the contact surfaces. In severe cases, plastic deformation causes mating gears to melt and strip off all the teeth.
