NUMBER 76  
APRIL/MAY  
2002  
\$5.95 U.S.

# Sterndrive Failures

The biggest obstacle to accurate damage-analysis could be your own preconceptions.

**Text and photos by Jonathan Klopman**

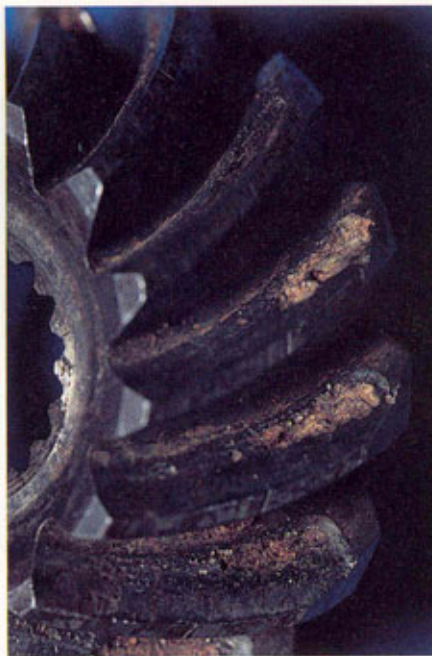
*A pinion gear, with pitting at the pitch line of the gear teeth. The gear had been running in contaminated oil for a long time before it failed. Another clue to water damage is the black splotches on the surface.*
